DAM INSPECTION CHECKLIST POSSUM POINT POWER STATION POND ABC

INSPECTION DATE: MARCH 15, 2016

INSPECTED BY: K. ACREE

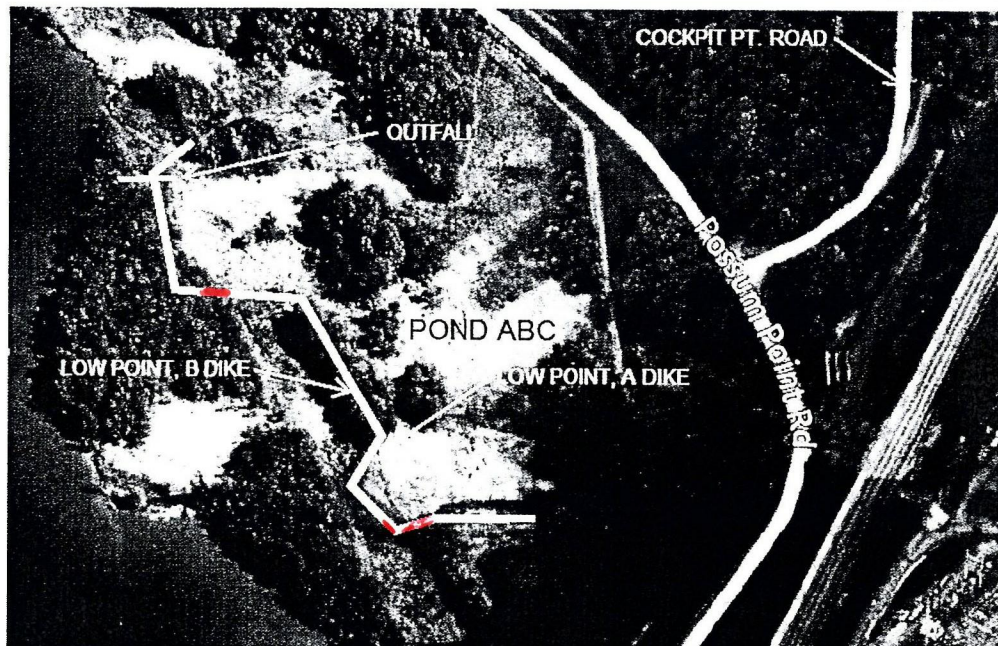
- LOW POINT, C DIKE @ 1242 → NO STANDING WATER AGAINST SAND BAGS, SAND BAGS ARE IN PLACE, AND SEVERAL SAND BAGS ARE RIPPED. NO FLOW OR EROSION.
- SOME STANDING WATER AT TOE OF POND A EMBANKMENT (TYPICAL OF POND B ARE)
- STANDING WATER AT TOE OF POND EMBANKMENTS (SEE FIGURE BELOW)
